**Objective:** This week's issue will cover the following subjects.

- 🌈 Water Trap
- 🌈 Fill Chamber Door Gasket

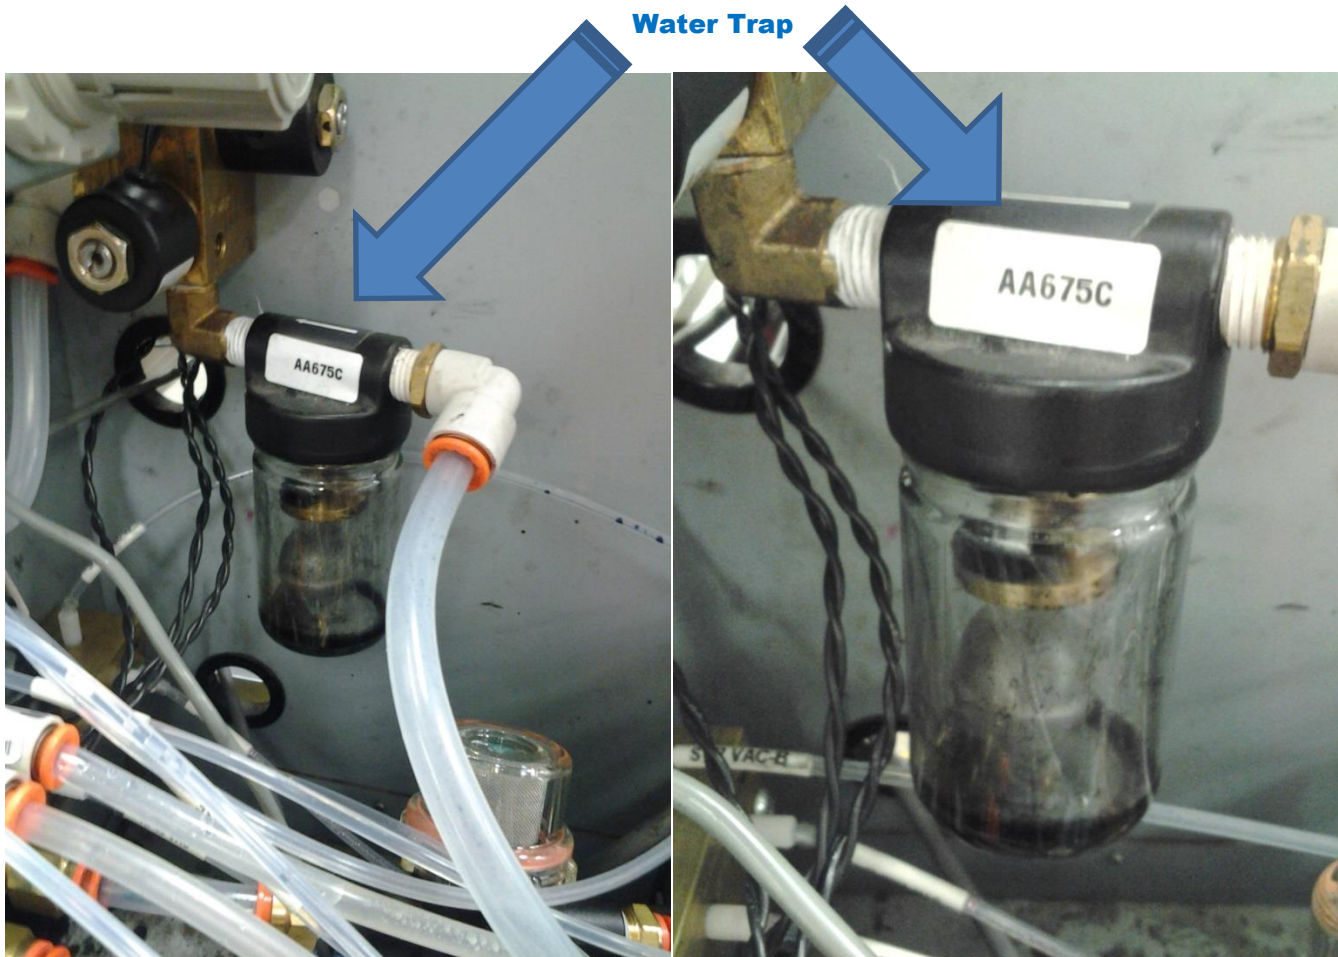
- 🌈 The Water Trap is located in the back left corner of the machine. It is attached to the Primary Vacuum Manifold.
- 🌈 If the trap starts to fill with liquid the ball in the water trap gets sucked up to the top. This will shut off the vacuum and generate a V001 Error code. The trap must be emptied and the machine restarted to clear the error.
- 🌈 **IMPORTANT:** Leave a few drops of liquid in the water trap jar.
- 🌈 **DO NOT:** remove all of the liquid in the water trap jar. If the jar is completely dry, the ball will bounce around in the jar and get sucked up into the top of the trap, shutting off vacuum and generate a V001 Error.

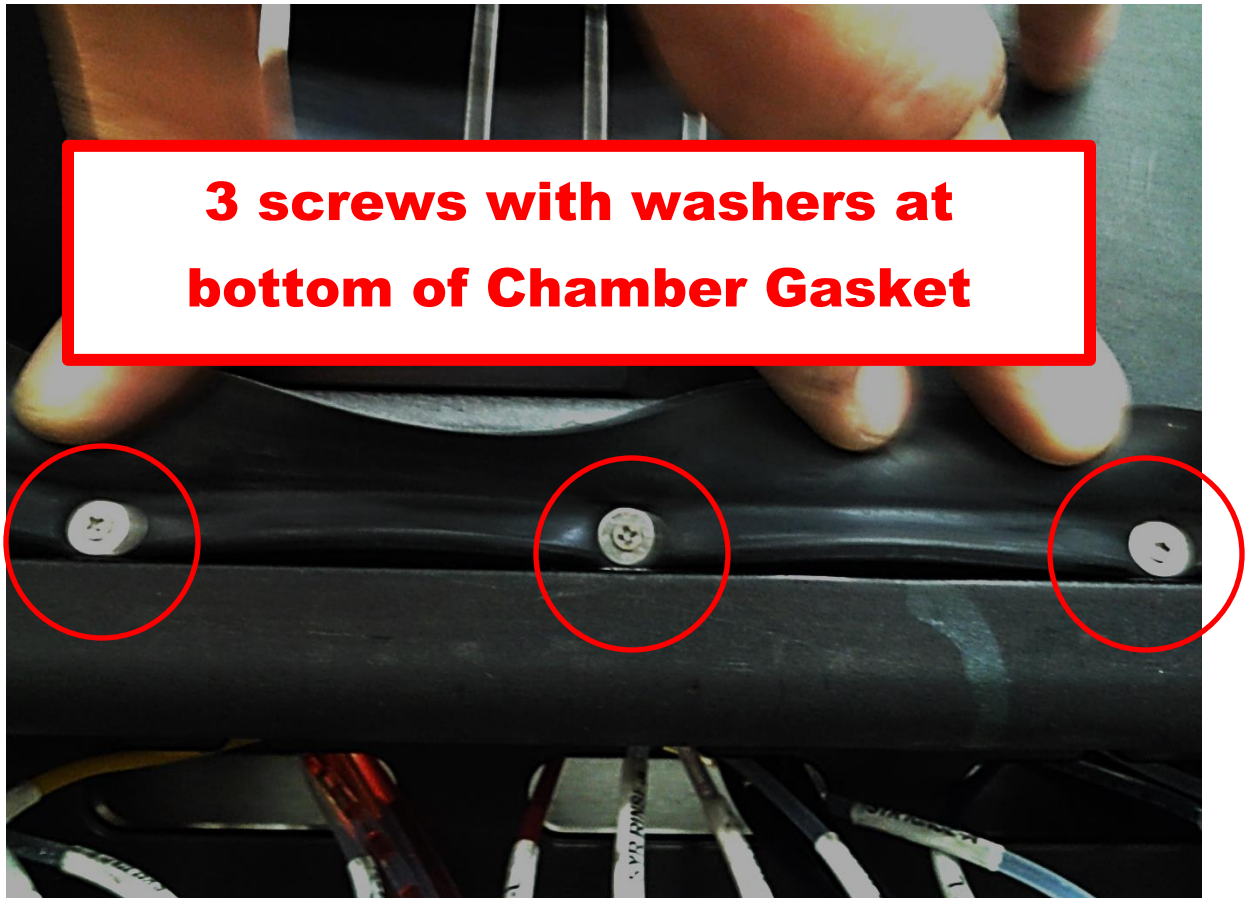
### Fill Chamber Door Gasket

- 🌈 When installing a new Chamber Door Gasket, there are a few important steps to ensure proper installation.
  - The new gasket may stick to the chamber door prevent a proper seal. Try to clean it with one of the cleaning wipes. If that does not work, using a small amount of powder or dust will help reduce the tackiness of the gasket.
  - If there is dirt or ink on or under the Door Gasket, it could cause a chamber leak. Cleaning those areas with a cleaning wipe will help.

- The New Gasket Kit comes with 3 screws and 3 metal washers. **The washers should be installed on the bottom 3 screws.**
- The 3 screws are to be used if some or the screws are lost or missing

- Some of the original machines do not have a hole in the bottom center of the gasket. Please use one of the washers and extra screws sent to create a new hole and securing point for the gasket

- There should be a total of 12 screws securing the gasket
  - 🔧 3 at the top
  - 🔧 3 on each side (L + R)
  - 🔧 3 on the bottom
- There is a video that shows the procedure. It is available from the Ink centers Help Tab
