Service Update InkCenter Revised 10/25/2013 Questions? Contact: whoeckh@retailinkjet.com

Objective: This week's issue will cover the following subjects.

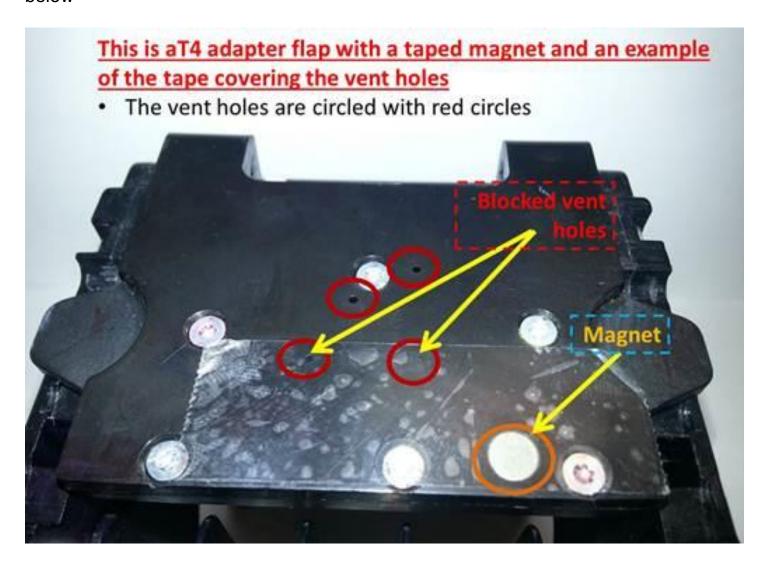
The magnet on the adapter that is used to detect the presence of the adapter in the station may fall out. If you can find the magnet, you may tape it back on to the adapter.

NOTE: only place the tape over the magnet, not over any of the vent holes in the prep flap or the cartridge will not prep properly. Please see illustration of blocked vent below
