Retail Inkjet Solutions

Objective: This week's issue will cover the following subjects.

Ink Nest

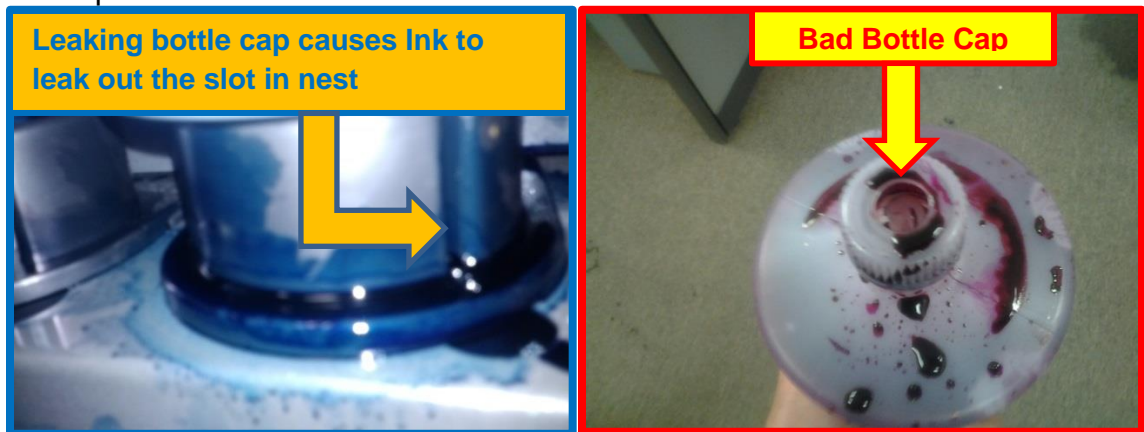
- Normally a leak around the nest is caused by either of these situations
 - The ink cap lost its seal and ink leaks out the slot in the nest. Replace the cap with one from an unused new bottle, and then order replacements from RIS. Customer can replace the ones that were borrowed.

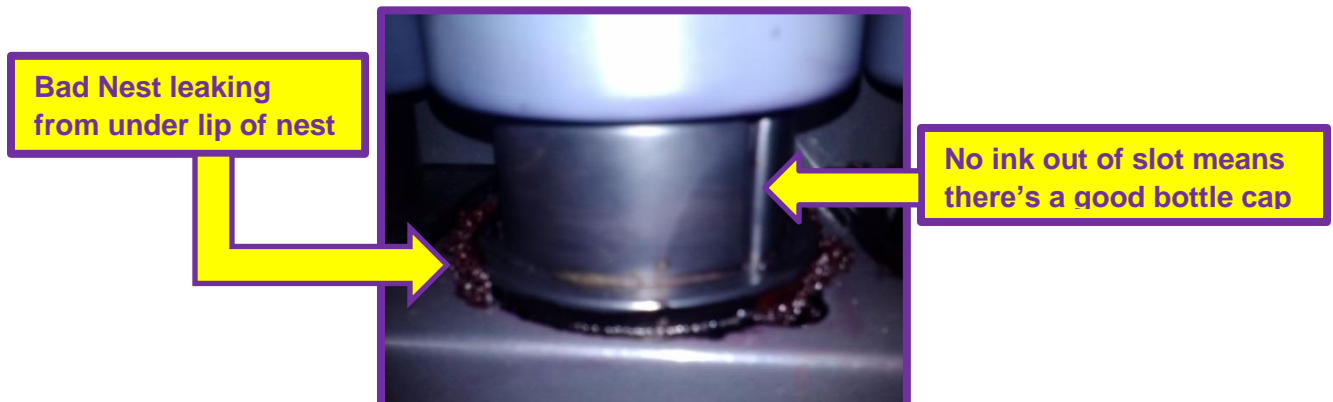
- The distribution valve may be bad or out of phase causing ink or cleaning fluid to be dispensed into the nest. Work with RIS tech support to diagnose this problem.
- During the initial production of the ink nests, there were some instances where the top of the nest would separate or crack from the bottom half, causing it to leak. The nests have been redesigned and now made much better. This is a VERY RARE issue and should only be found on machines with a serial number lower than 200100.

- The nest will need replacement for the following reasons
 - The float sensor does not detect ink in the nest properly. It will indicate the nest is always full or empty.
 - The needle in the center of the nest has broken off or come out with the ink bottle
