Service Update InkCenter

Revised 05/06/2013 Ver C Questions? Contact: whoeckh@retailinkjet.com

Objective: Provide information on what is new with the Ink Center

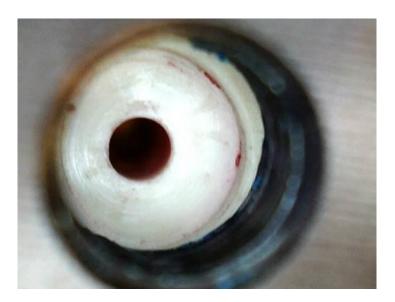
GOOD WHITE WASHER IN PLACE

- In general the white washer should only be replaced if damaged or compressed to the point where it occludes the opening in the port. Only one washer is needed.

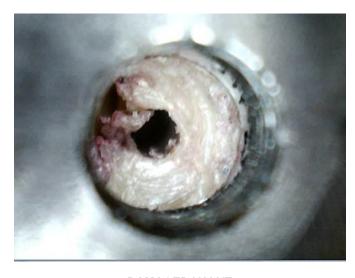
- Damage to the valve body (internal part of the distribution valve) during tech repair.
 - This refers to any of the ports on the distribution valve, but specifically to the syringe port which also has a white, Teflon washer in place.

- During a syringe replacement, it appears that some techs are either incorrectly trying to remove a missing white washer, or are being too aggressive when removing the white washer in place. Because of the lighter color of the valve body, it's possible to mistake the portion of the valve body that is visible in the valve port for the white Teflon washer. Please reference the photos below and notice the damage to the valve port.

DAMAGED VALVE

- We are also working on instructions on how to correctly remove and replace the washer, and possible identifying the best tool to do so without damaging the valve body material.
