Objective: Provide information on what is new with the Ink Center
The new style Chamber doors require a software update.

New Style Chamber doors

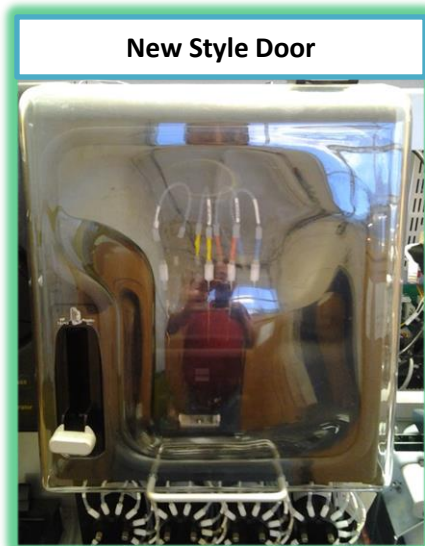
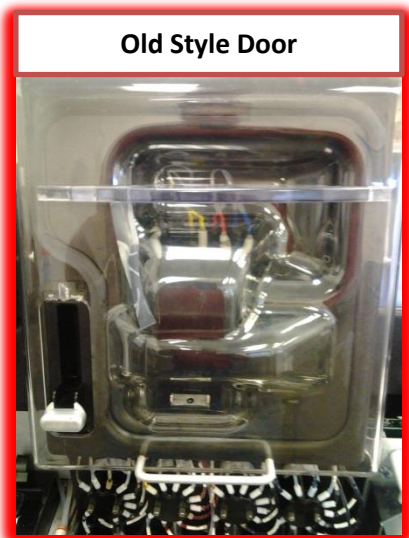
- The new style doors are now being shipped to sites when theirs becomes broken or cracked.
- The new style doors do not have the supporting brace across the front.
- It is designed to last longer. .
- Since the new style door gives the chamber more volume it takes a little longer to achieve max vacuum and to vent after a fill. This timeframe will vary depending on the type of vacuum pump being used (older blue pumps reach max vacuum quicker than the newer gray vacuum pumps). On average, both the fill and vent process will take approximately 10- 15 seconds longer.
- The new style door requires a different software profile. Without the correct profile, overspills and fills cancelling may become more apparent.
- Stop notices are being placed on the door, instructing operator to call for SW update.
