**Objective:** Provide information on what is new with the Ink Center  
**The new style Chamber doors require a software update.**

### New Style Chamber doors

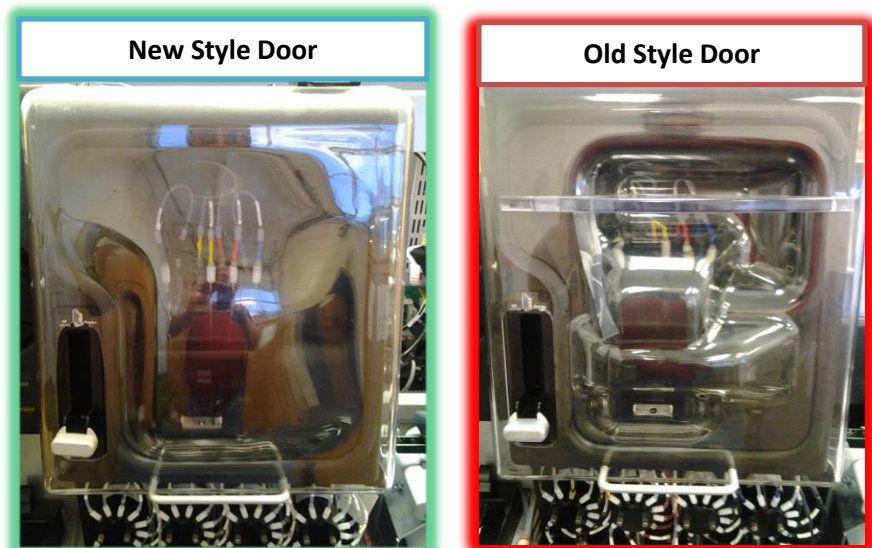
- The new style doors are now being shipped to sites when theirs becomes broken or cracked.
- The new style doors do not have the supporting brace across the front.
- It is designed to last longer. .
- Since the new style door gives the chamber more volume it takes a little longer to achieve max vacuum and to vent after a fill. This timeframe will vary depending on the type of vacuum pump being used (older blue pumps reach max vacuum quicker than the newer gray vacuum pumps). On average, both the fill and vent process will take approximately 10- 15 seconds longer.
- The new style door requires a different software profile. Without the correct profile, overspills and fills cancelling may become more apparent.
- Stop notices are being placed on the door, instructing operator to call for SW update.
