Service Update InkCenter

Objective: Provide information on what is new with the Ink Center

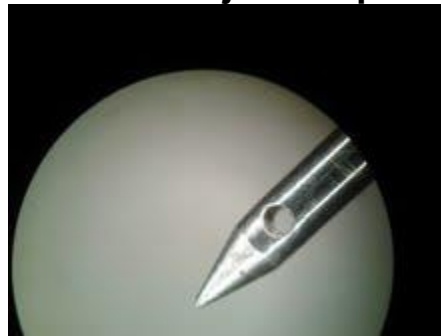
Good Injector tip

Most locations are now using the new style injector needles. The way to test these for proper flow is different from the old style. The old style you could run the injector under water and it would flow out the large hole in the tip. The NEW style has 2 smaller holes. To properly test the new style, block one of the holes with you finger to check the flow of the other hole. Repeat for the other hole.

NOTE: Improper use of the new style injectors will cause the tip to collapse. When checking injectors the integrity of the tip needs to be inspected also. See images below for examples:
