Retail Inkjet Solutions

Objective: This week's issue will cover the following subjects.

Ink Nest

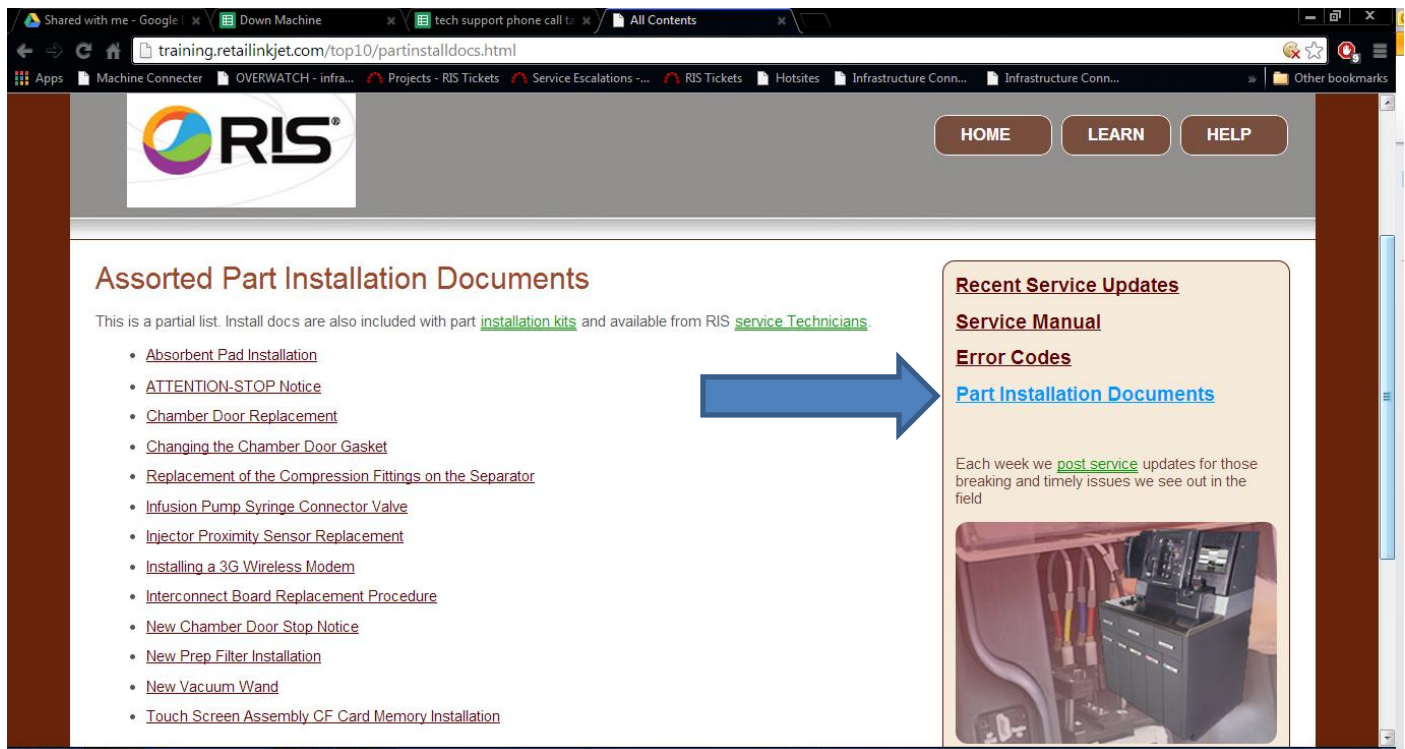
- The high usage service parts ship with printed documents describing the replacement procedure
- If the document is lost or misplaced, you may review the material from the **Ink Center Help Tab \ Service Technician login**. Access code is 741963. They are also available for viewing or downloading from any PC or handheld device.
- <http://training.retailinkjet.com/top10/partinstalldocs.html>
