Service Update InkCenter

Objective: Provide information on what is new with the Ink Center

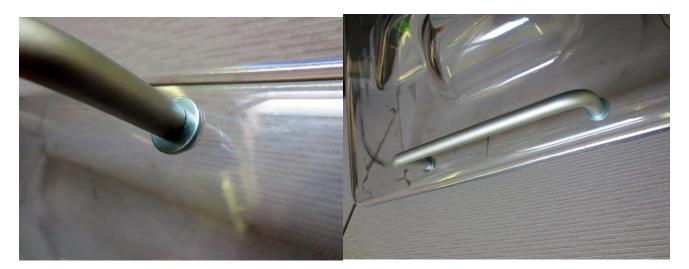
Chamber Door Change

Effective immediately, two flat washers will be shipped with the chamber doors. The screws should be used to reinforce the handle. Instructions will be included with parts.
